# DIGGING DEEP

to complete NZ's toughest HDD project

# Slips, rust & fatigue

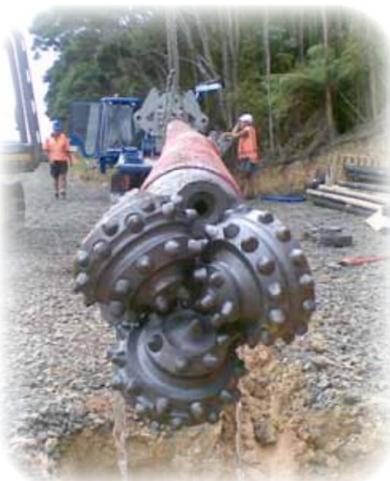
▲ Mud motor with electronic compass steering system

Pilot drilling progressed 900m before a hard turn upwards under the last stream was required to meet the exit target 140m away and 40m vertical. However the mud motor failed to achieve the targeted vertical gains and the exit location was going to be over shot. Drilling on may have resulted in drilling into the existing cast iron watermain or exiting under the floor of the filter station building.

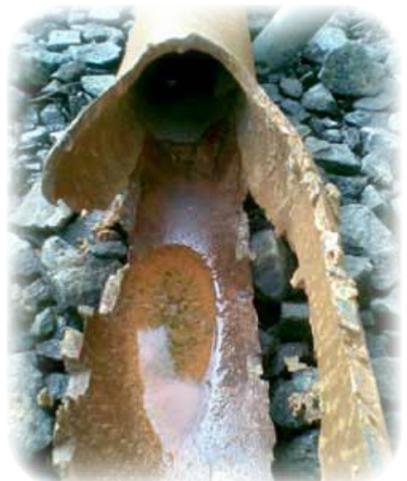
▲ Exploded drill rod to recover drill string

It was suspected that sand falling into the pilot hole had packing behind the mud motor caused the tool to jam.

New down hole equipment was ordered from overseas and UUL went about salvaging as much of the drill string from the hole as possible. An explosive charge was feed down the drill string and 350m of rods were eventually recovered.

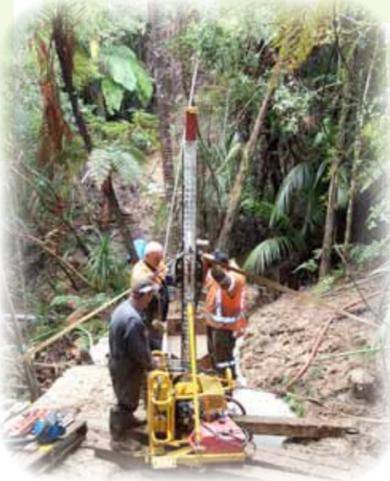
A heli drill rig was dropped into the bush and two ground investigation bore holes were drilled revealing substantially weak beds of barely cemented sands.

▲ Heli rig used for grout injection and additional ground investigation

Grout injection was undertaken in tunnel gully to help stabilise the formation.

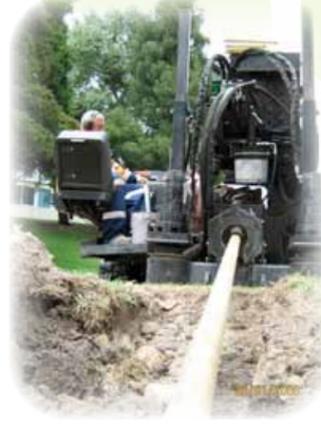
◀ Ditchwitch 30/20 drill rig utilised to drill down to and intercept the existing pilot hole

UUL conceived utilising a small drill rig to drill down the steep embankment and intersect the existing pilot hole nine metres below the stream and 40 metres below the small drill rig platform. The difficulty of this manoeuvre was no small feat. The small drill had to land its drill string into a 260mm diameter pilot hole like landing an aeroplane. Simply drilling straight to the existing pilot hole would not work. The steep and densely vegetated embankment and depth of the drilling made the operation very tricky. The drill string had to achieve a depth of 18 metres before arriving under the stream on line and grade. Every longitudinal metre had a different grade to achieve as it bent around to eventually match the target grade. A survey and computer bore plan was undertaken for the shot and recalculated every 15m.
