# MEADS HILL, SH3 “On the move”

“Drying out the slip zone”

Meads Hill is located 5km south of Te Kuiti on state highway 3. This section of state highway was constructed across a steep gully of earth and in recent times was on the move. SH3 is a strategic link between the Waikato/Auckland and Taranaki regions and the stabilisation was a priority for Transit.

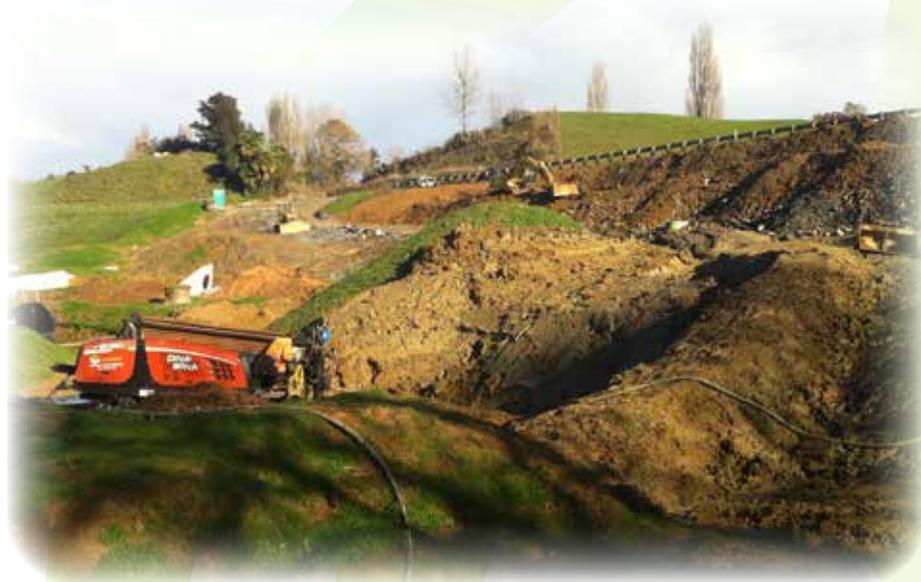
▲ Meads Hill Embankment

Several remedial actions were undertaken to stabilise the embankment. These included drilling and concreting three rows of timber piles up to 8m deep parallel to the road and into the Papa rock beneath the slip, removing trees, placing rock riprap and dewatering the slip zone.

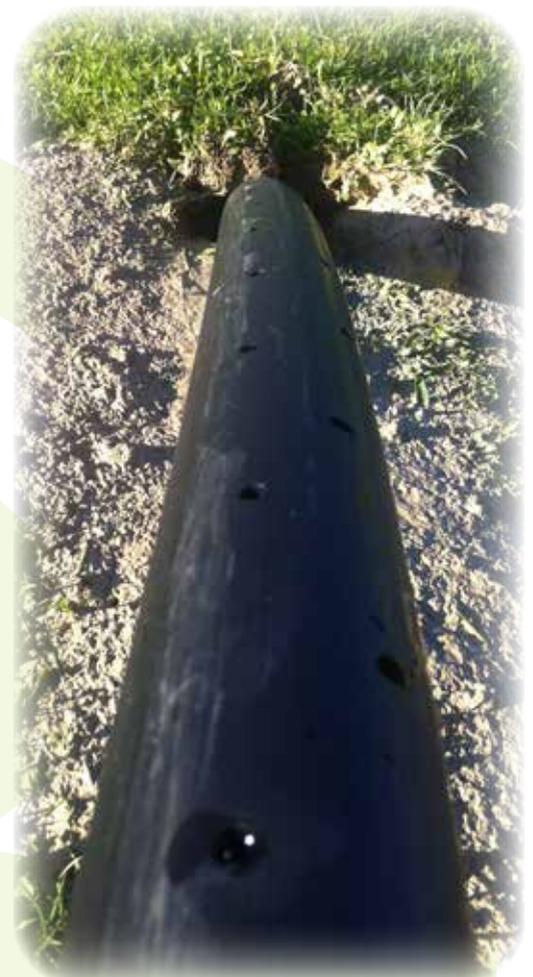
▲ 63Ø OD PE F2 drilled pipe

No supplier could be found to make the transit F2 pattern drilled coil PE pipe so Universal Underground made it themselves.

A bench and jig was set up on site and pipe drilling undertaken during installation. Nearly 1000m of pipe was installed with most pipes running half to nearly full of ground water immediately after installation.

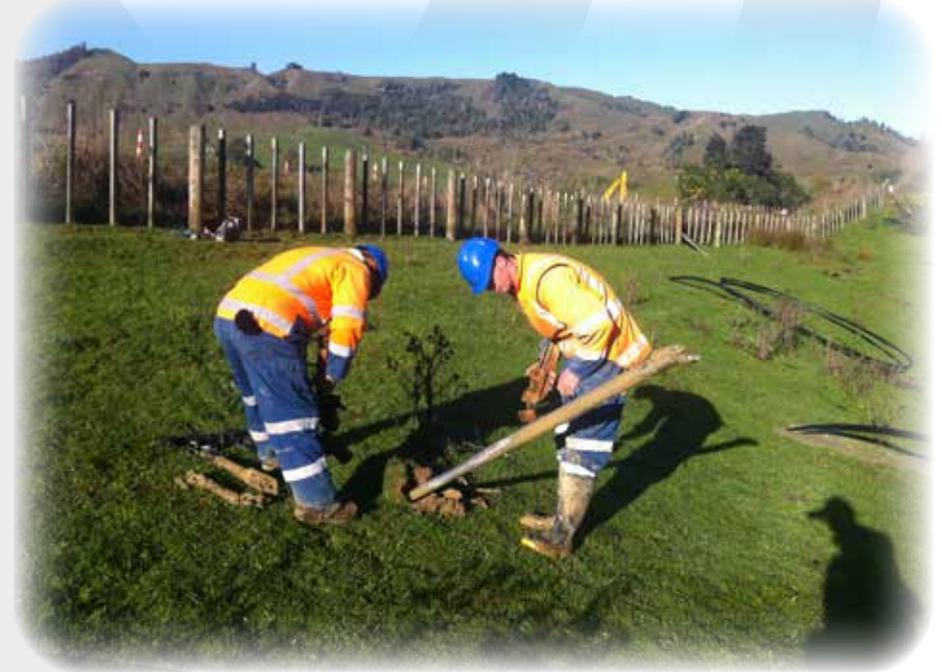
▲ After following the rock/soil interface the drill head exited the ground. The F2 pattern drilled pipe was connected and pulled back along the slip zone.

Universal Underground came up with a method to directional drill between the piles, following the rock all the way to the other side of the road and exiting the ground in a paddock where the pipe was connected and pulled back.
